**Flood Control Project Maintenance  
Levee Inspections**  
**LMA District Cover Sheet**  
**Spring 2020 Levee Inspection Results**

**Sutter Maintenance Yard Hamilton Bend**

**Levee Inspection Report By Mile - Spring 2020**

Waterway	Bank	Unit Miles	Inspection Start/End	Inspector
Unit No. 01 Feather River Hamilton Bend	Right	3.39	03/18/2020 03/18/2020	Sterling York

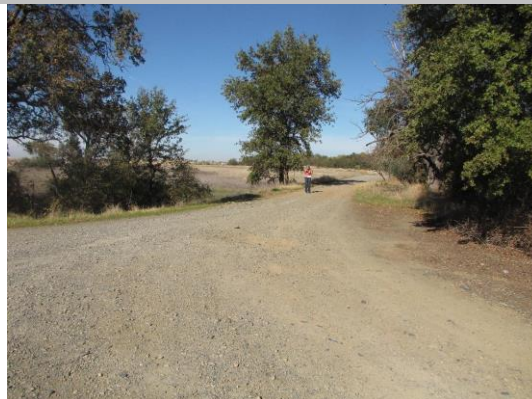
Photo 3 of 3 : UCIP\_SP\_2020\_55888\_21680.jpg

LM Start	<b>3.25</b>	Rating **	M	Issue No.	<b>19 (cont)</b>
LM End	<b>3.25</b>	Issue Type +	En	Location *	
Category	Supplemental		GPS Latitude/Longitude		
			Start	End	
Item	DWR UCIP Field Study		39.470269 °	39.470269 °	
			-121.609229 °	-121.609229 °	
DWR ID	17044

View of levee looking upstream.
